Life Moerdijk Bridge prolonged

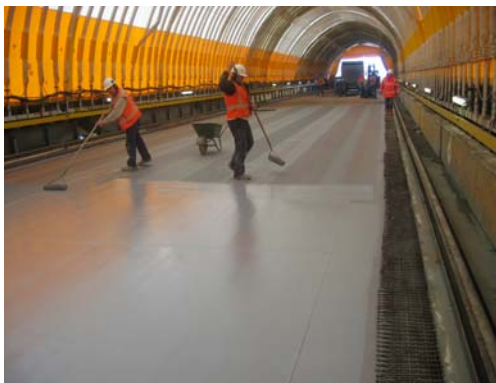
The Moerdijk Bridge connects the Dordrecht island and North Brabant over the Hollands Diep and is one of the busiest bridges in the Netherlands. Due to the increasing mechanical loads caused by the daily lorry traffic transporting cargo to and from the harbours of Antwerp and Rotterdam, the steel road foundation of the Moerdijk Bridge is subject to crack formation. Over the past few years, the length of the cracks and the frequency with which new cracks formed, has become truly alarming.

After several inspections, the Construction Service of the Department of Public Works decided to deal with this problem by applying high-strength concrete. This implies that the asphalt is removed from the roadway first. Next, the steel foundation inspected for cracks. If possible, the cracks are welded up. If this is not possible, then the capping is replaced. After this, the surface is sandblasted to Sa 2.5 and then the most important part of the renovation begins: applying the Bolidt primer, the epoxy binder and the calcinated bauxite. Bolidt has developed a special epoxy binder for this, [Boligrip® W/MDB](#).

The primer, the Boligrip® W/MDB adhesive layer and the calcinated bauxite make the concrete bond to steel. The adhesive layer also prevents chlorides and salts from penetrating the steel and thus has excellent anti-corrosive properties.

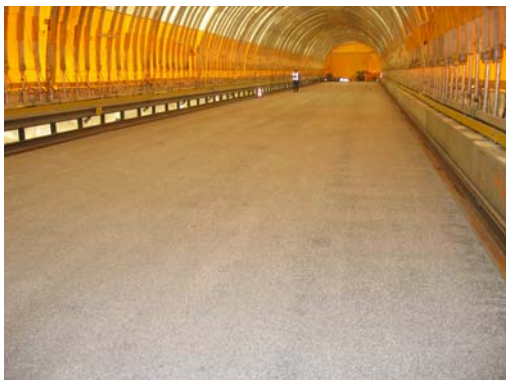
In order to shut out the weather the work takes place in a conditioned environment (tent).
